**THE 2004 INDIAN OCEAN TSUNAMI IN THE MALDIVES:
SCALE OF THE DISASTER AND TOPOGRAPHIC EFFECTS
ON ATOLL REEFS AND ISLANDS**

HIRONOBU KAN, MOHAMED ALI, AND MAHMOOD RIYAZ

**ISSUED BY
NATIONAL MUSEUM OF NATURAL HISTORY
SMITHSONIAN INSTITUTION
WASHINGTON, D.C., U.S.A.
DECEMBER 2007**

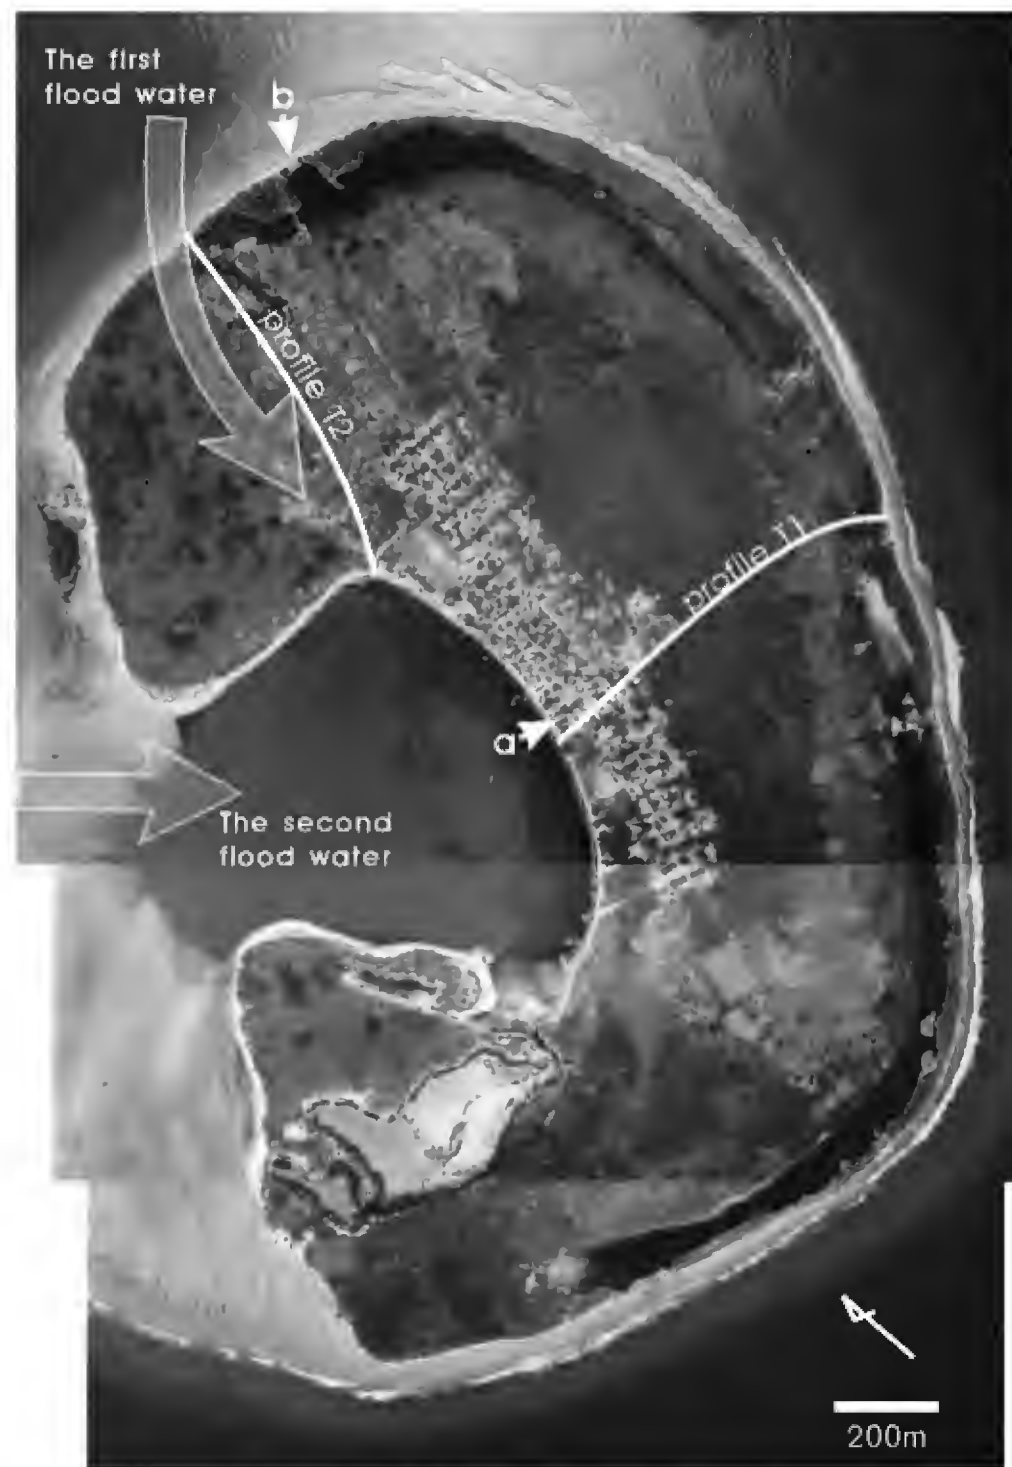
Figure 12. Transects and direction of flood water on Baarah, Haa Alifu. Aerial photographs were taken in 1999 by the Maldivian Government. a, b: photographic sites for Photos 3 and 4, respectively.

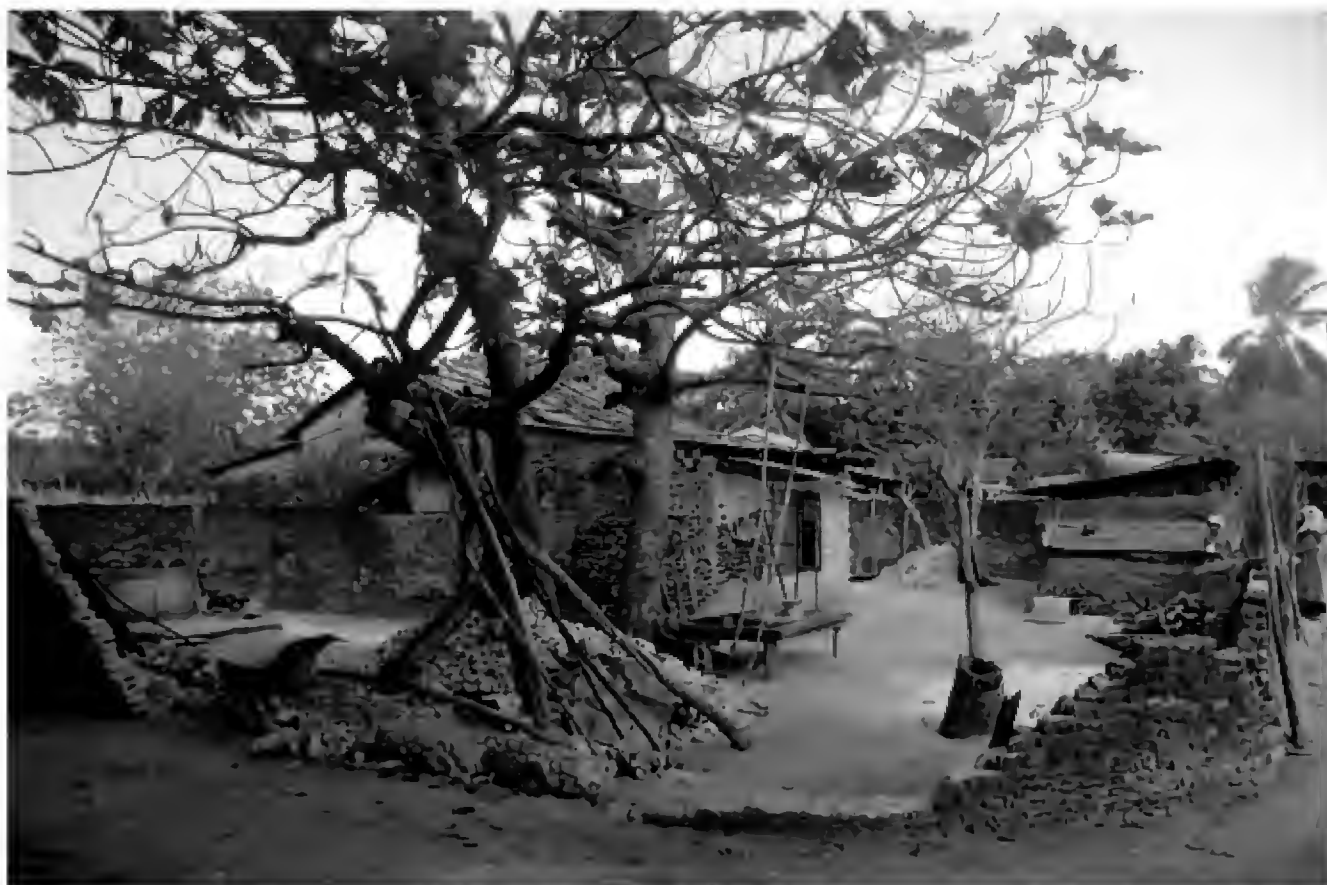
Photo 3. A collapsed wall at the lagoon-side on Baarah (February 2005).

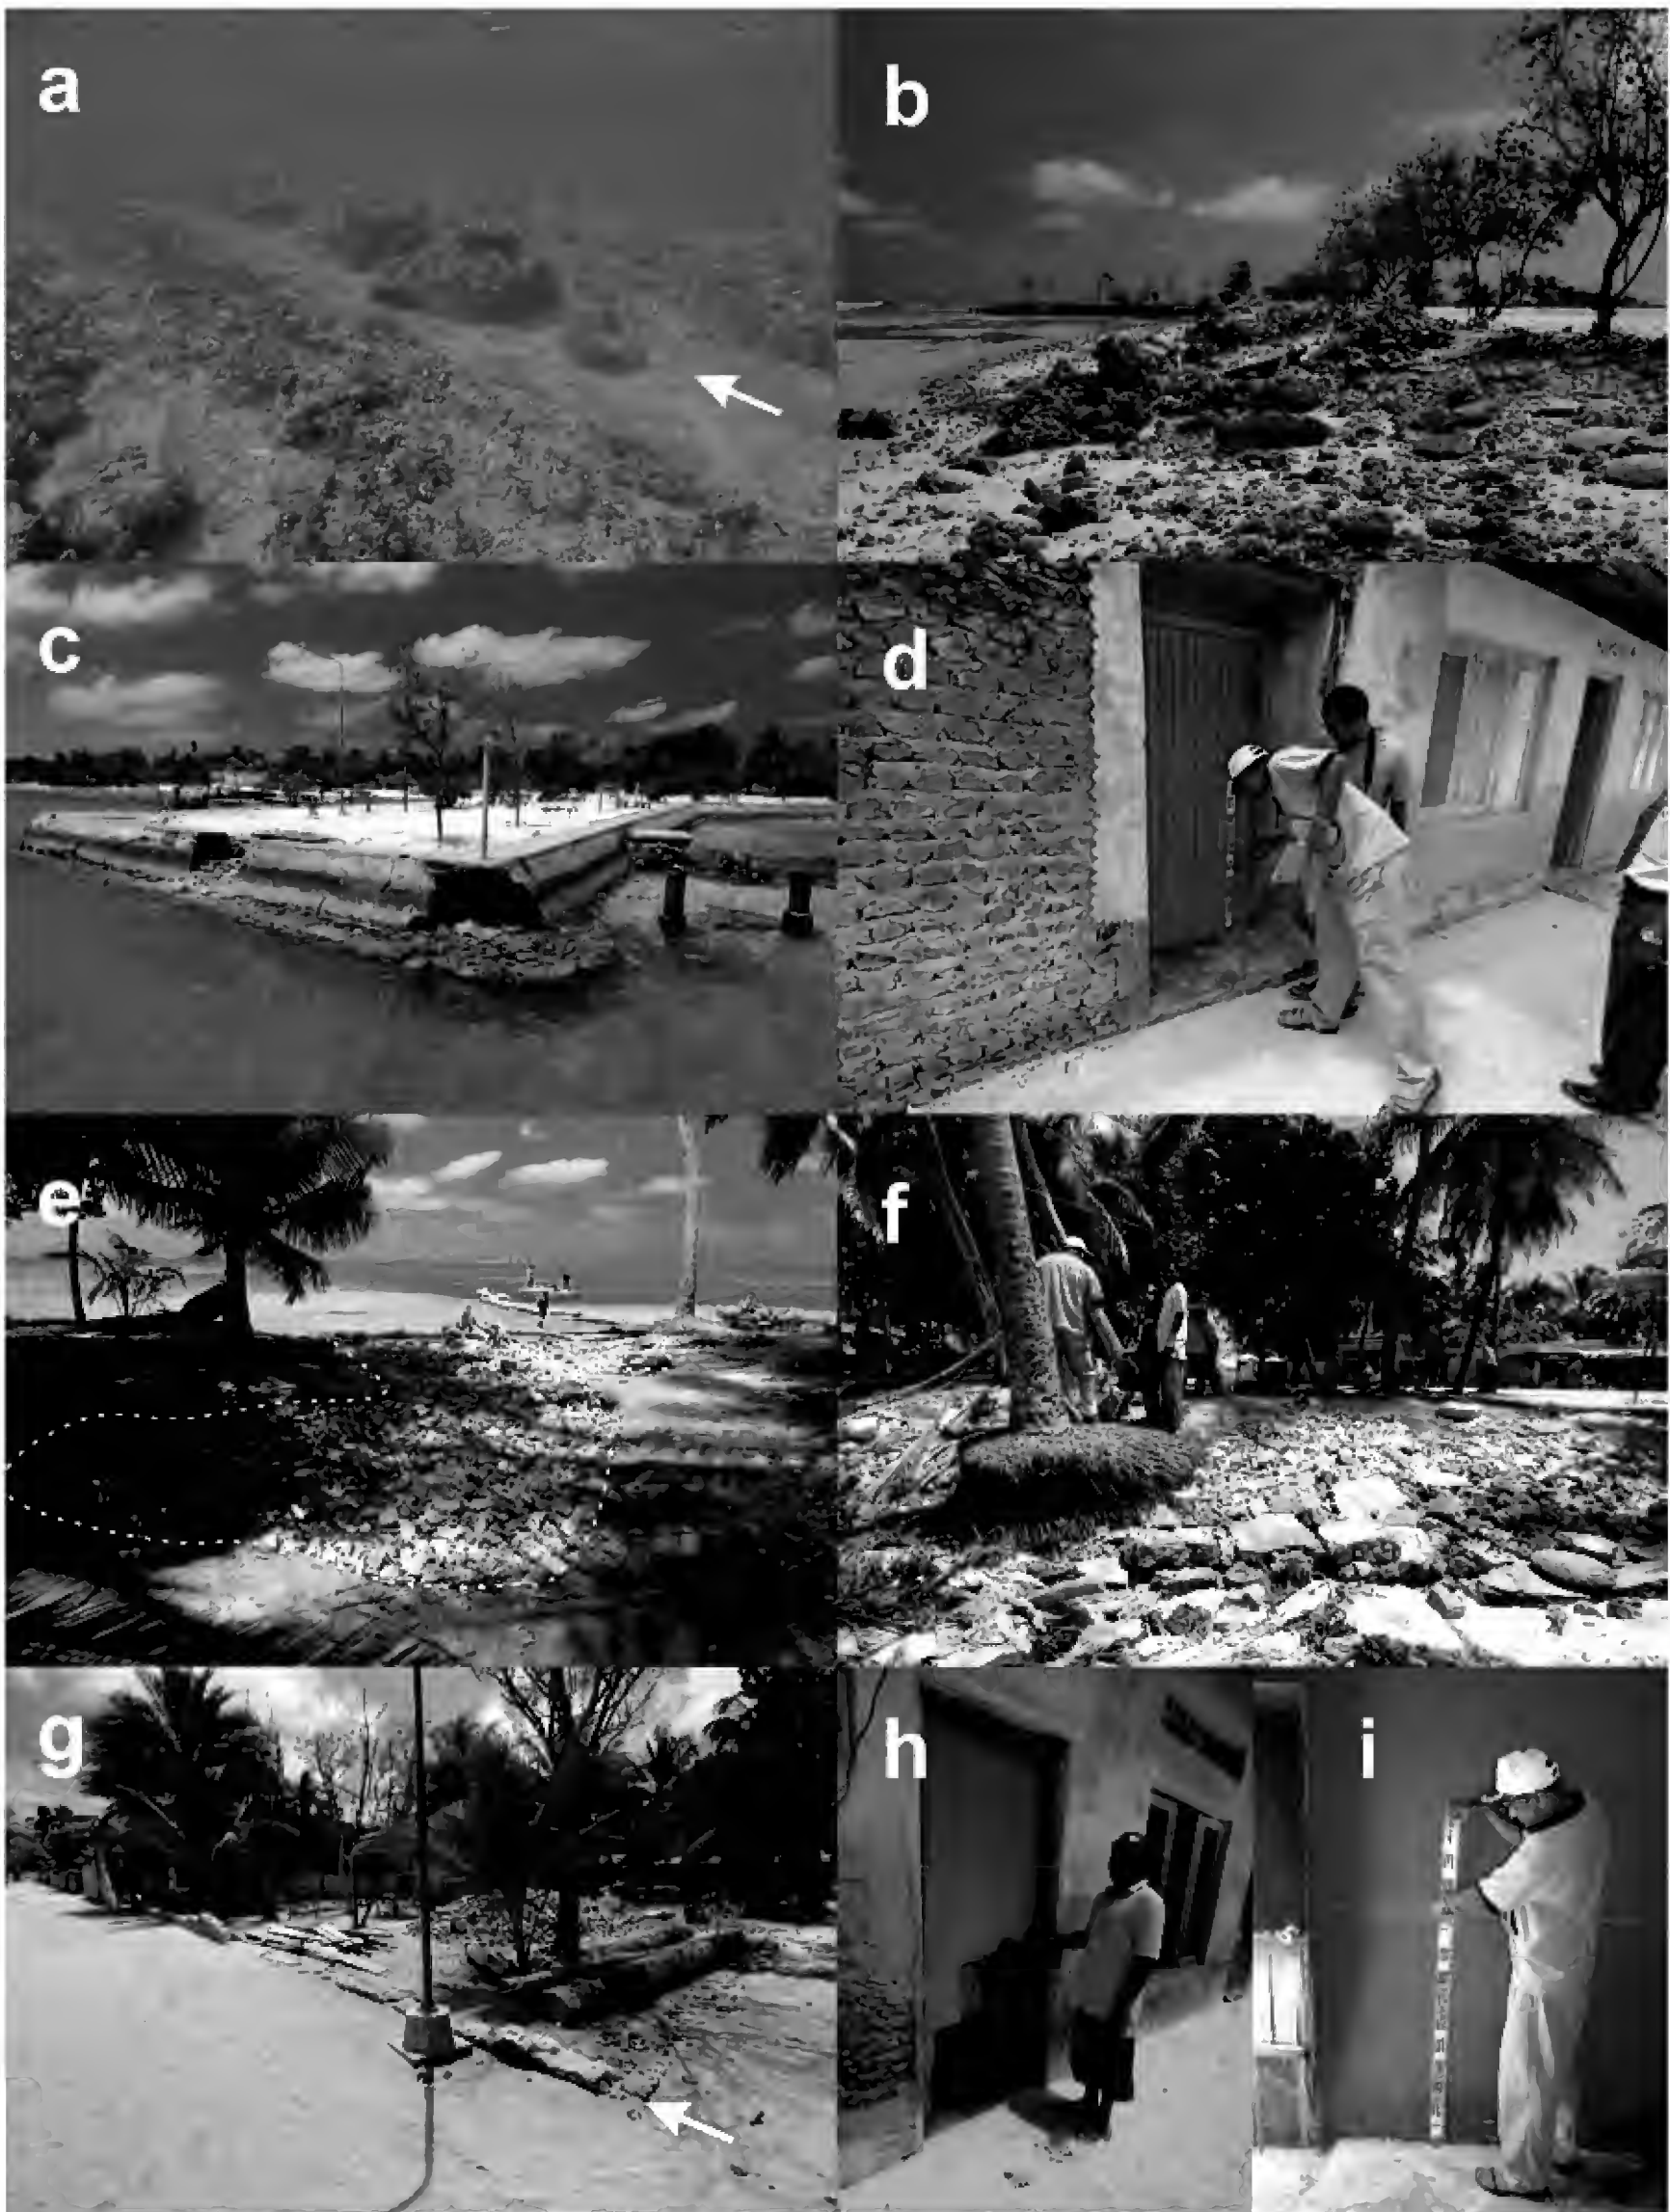
grooves above a 3 m depth (Photo 7a). A fisherman told us that these boulders were not there before the tsunami. The maximum diameter of the boulders was 2.5 m and they were distributed in a spurs and grooves zone at water depth of less than 3 m. Reef blocks and debris from collapsed buildings accumulated along the eastern coast of Dhiffushi (Photo 7b). Damage to harbor facilities was also observable (Photo 7c).

Photo 7. Post-tsunami photographs of Dhiffushi (February 2005). a: reef blocks arranged in a row in a reef edge groove of 3 m depth, on east Dhiffushi; b: harbor debris at the eastern coast; c: harbor damage at the eastern coast; d: watermark near the eastern coast; e: scouring (dashed line) at the western (lagoon-side) coast filled in with debris by the residents; f: beach erosion at the western coast; g: destroyed wall at the western coast; h, i: watermark near the western coast.

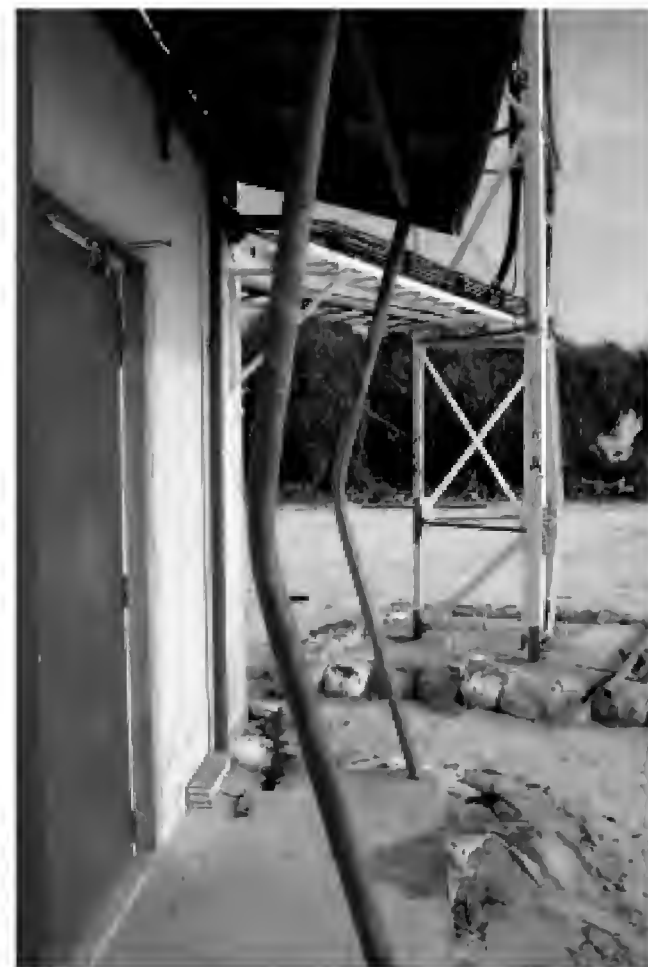
Photo 10. Damaged telecommunication facility at the northeastern side of Raiymandhoo.

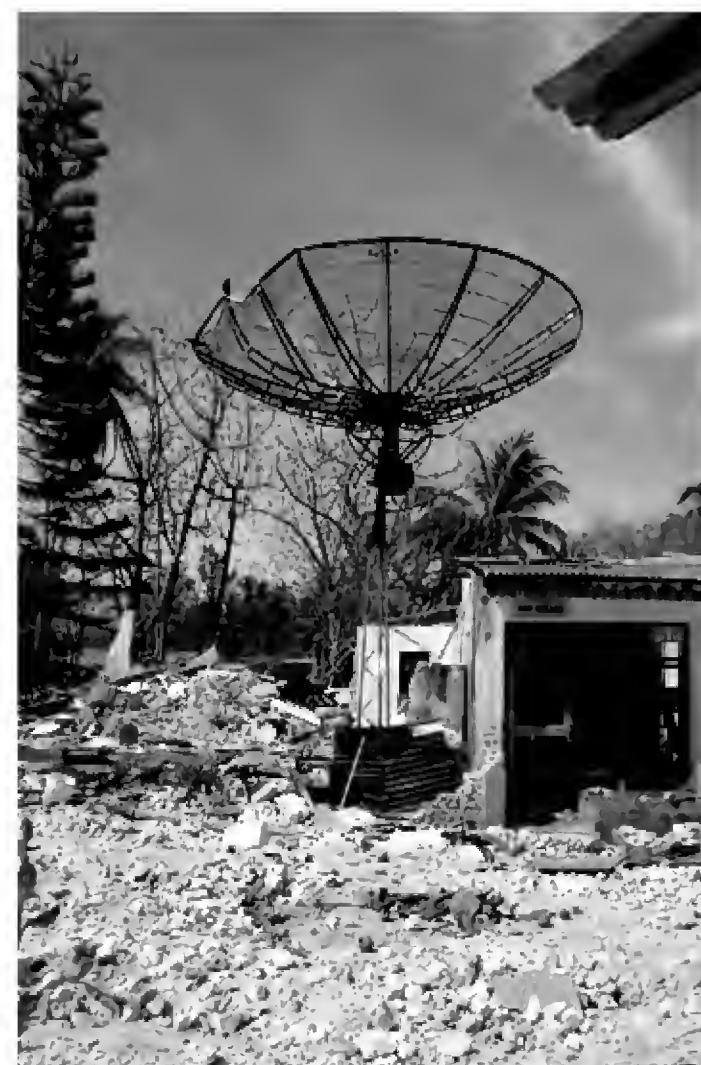
Photo 13. Deformation of parabolic antenna on Madifushi (March 2005).

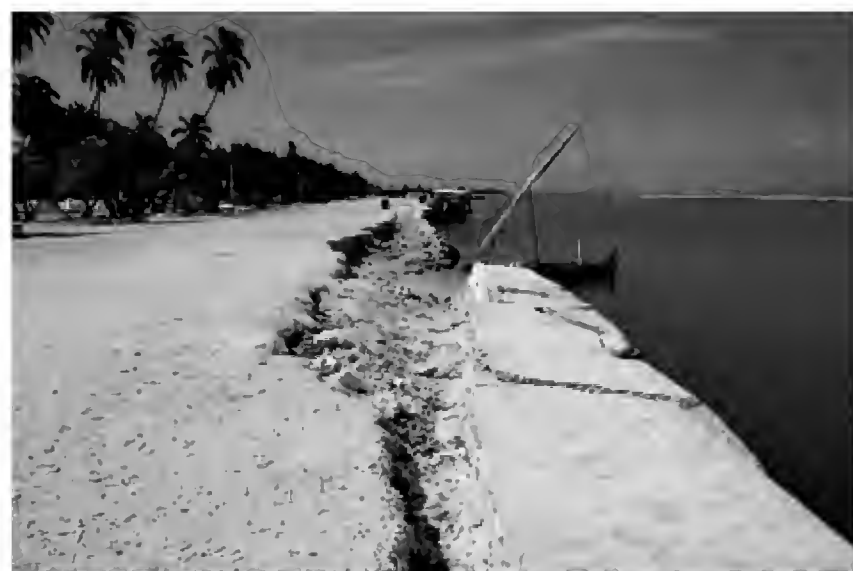
Photo 16. Damaged harbor at the western coast of Muli (March 2005).

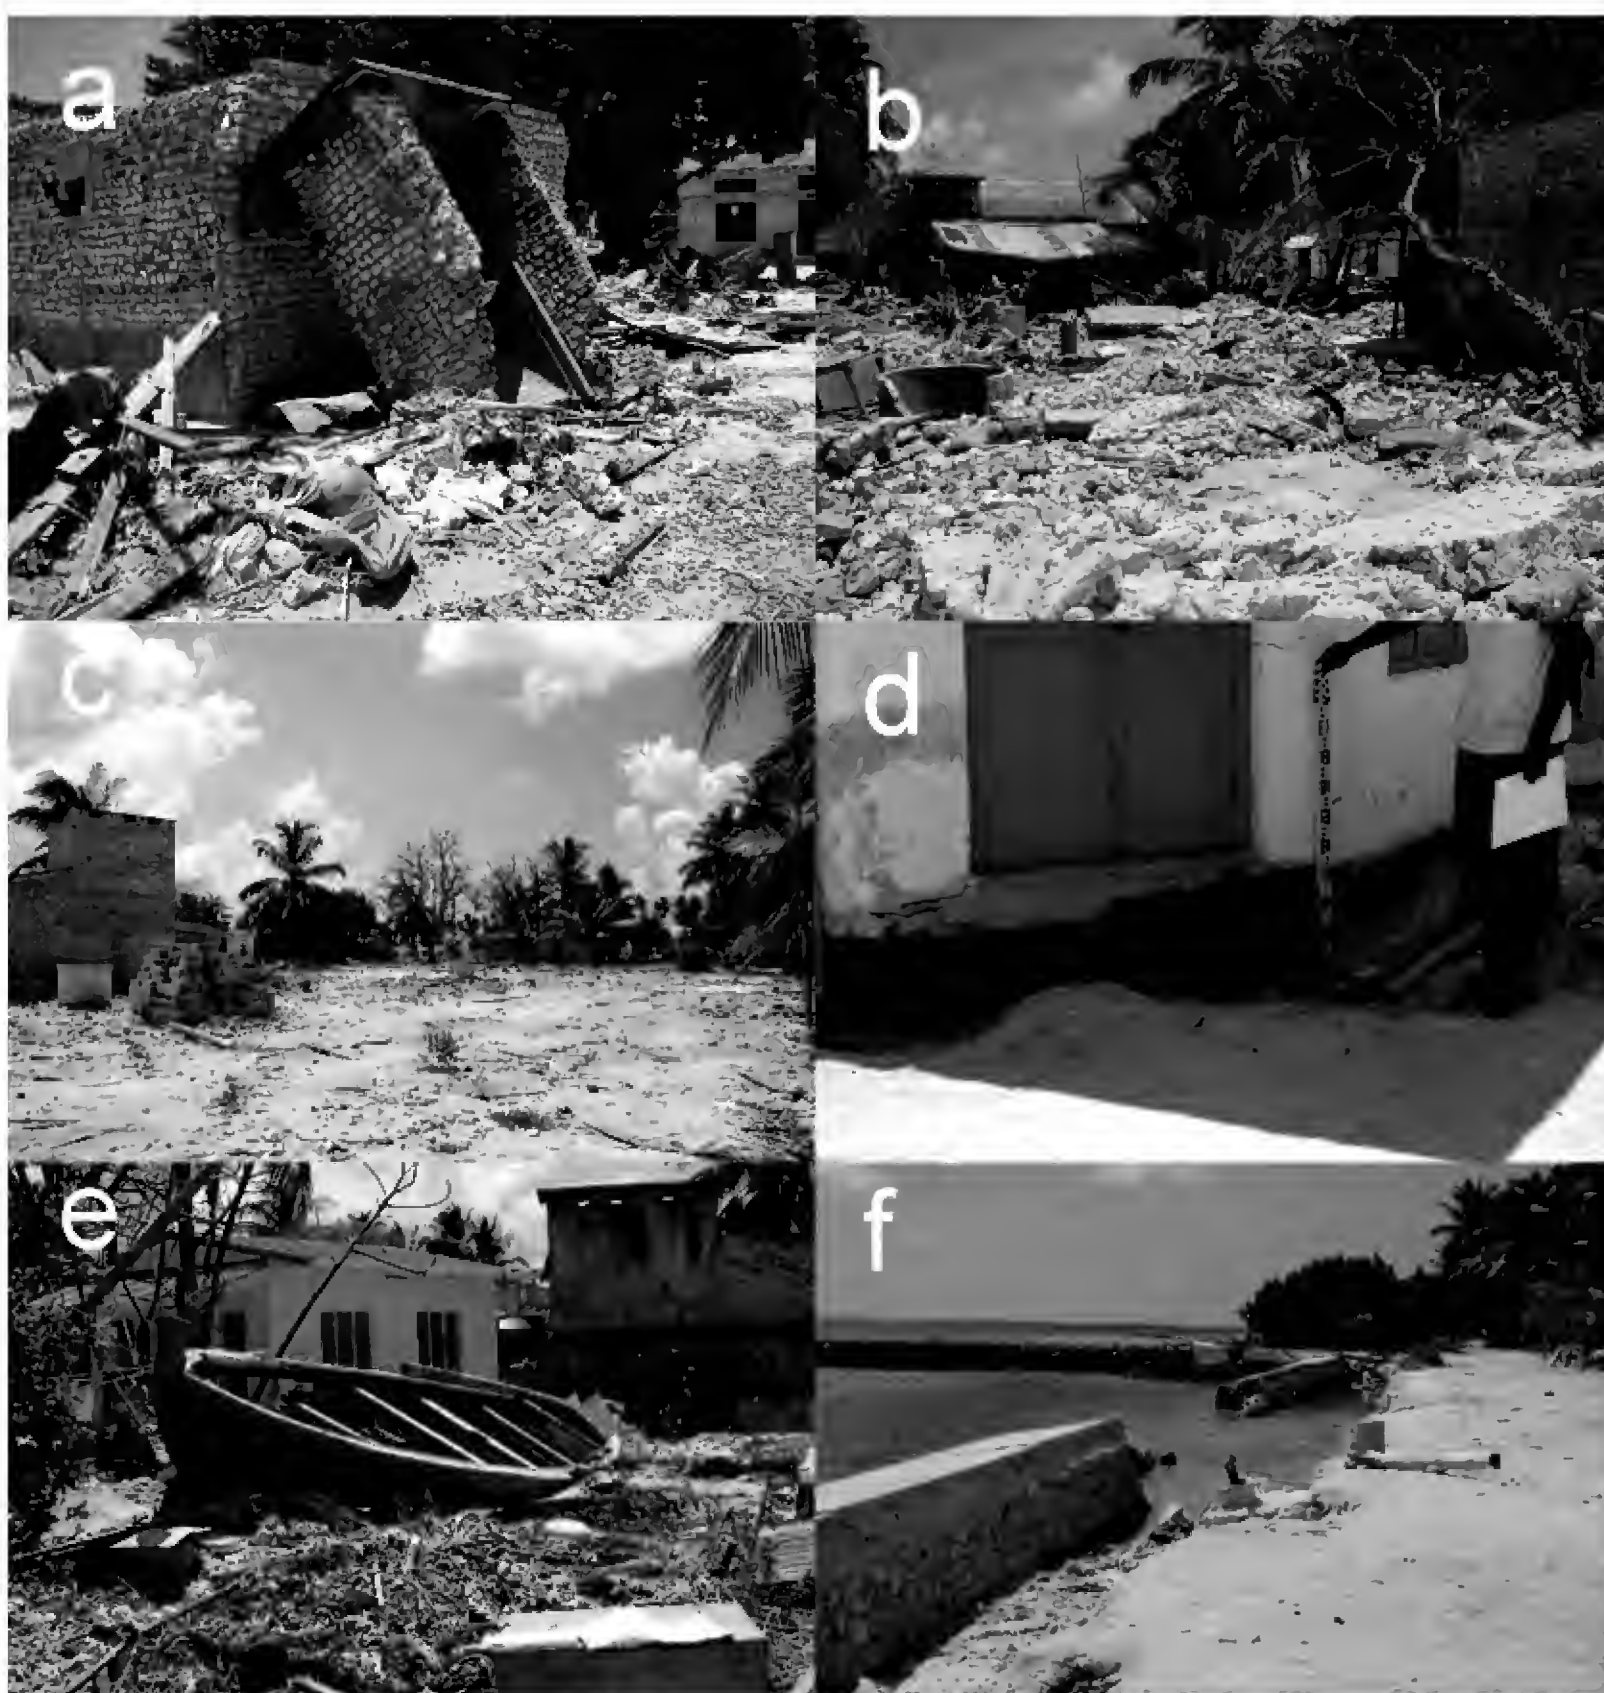
Photo 20. Post-tsunami photographs of Vilufushi (March 2005). a-c: destructive damage in the settlement area; d: scouring under a house; e: dhoni run up into the village; f: harbor damage at the western coast.

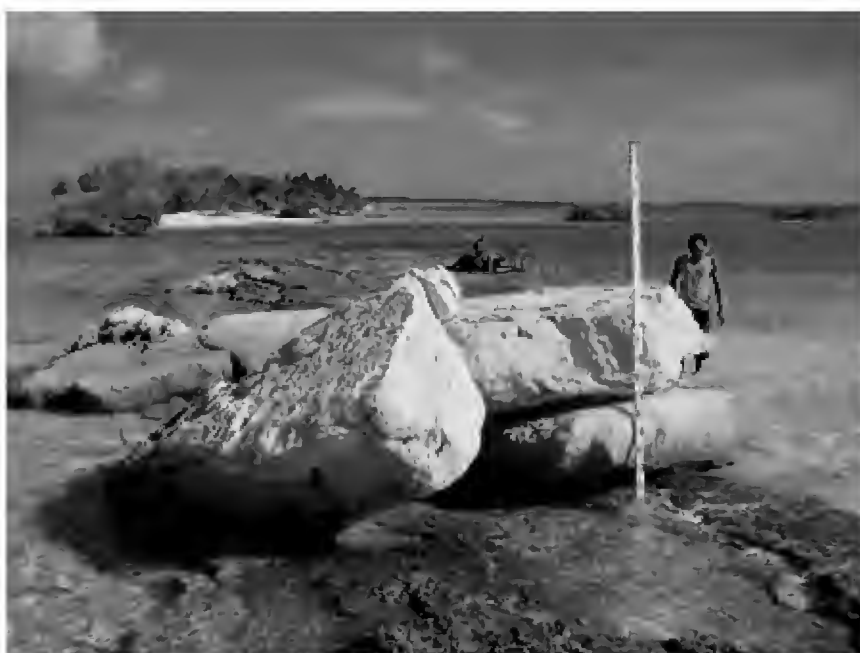
Photo 21. Block of beach rocks torn off and piled up on Kalhufahalafushi (March 2005).

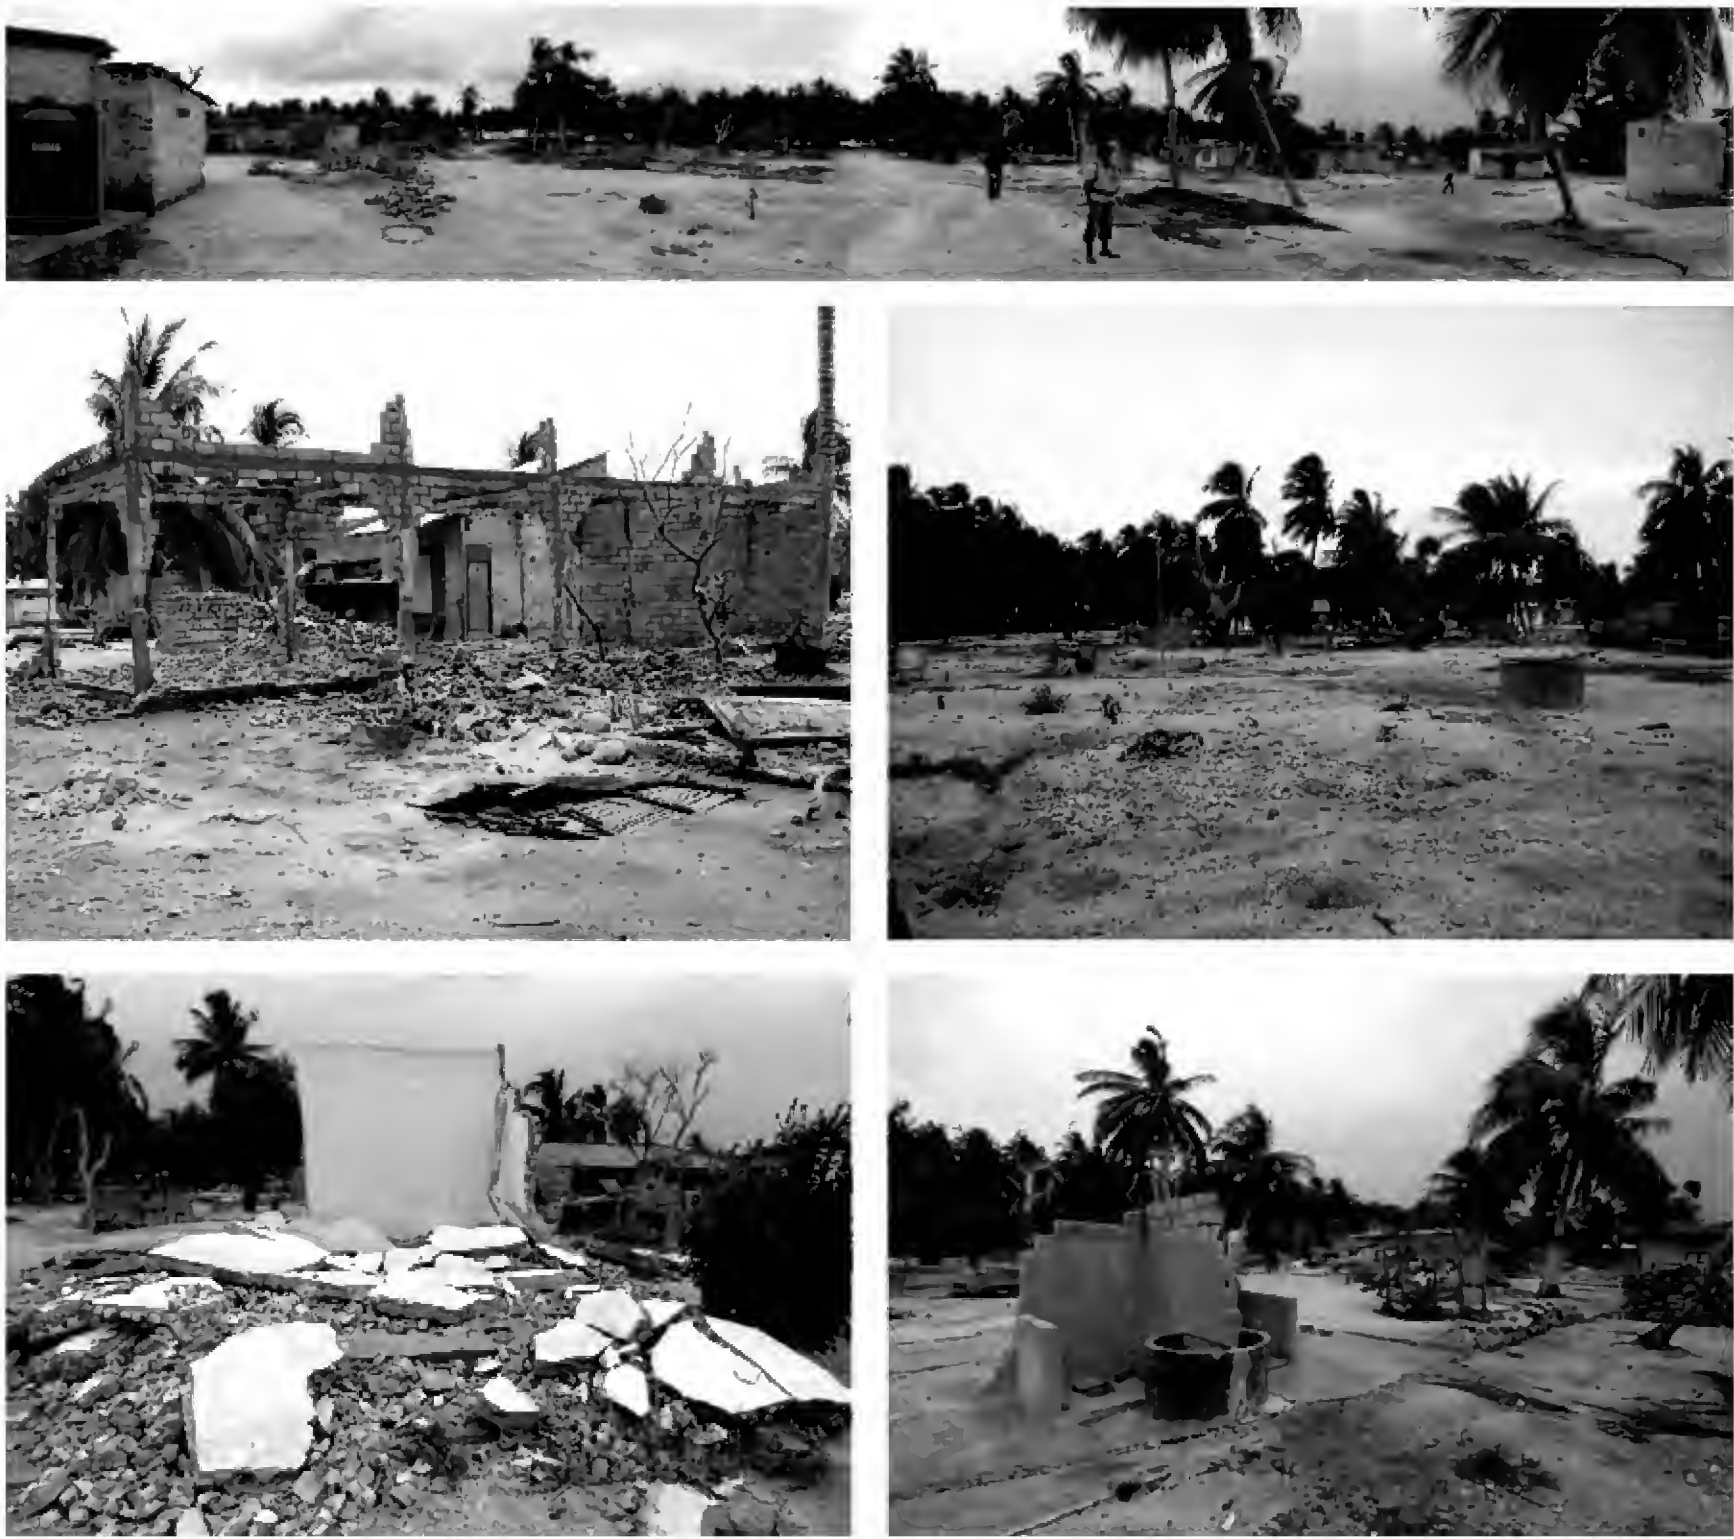
Photo 25. Destroyed area near the eastern coast of Maabaidhoo (August 2005).

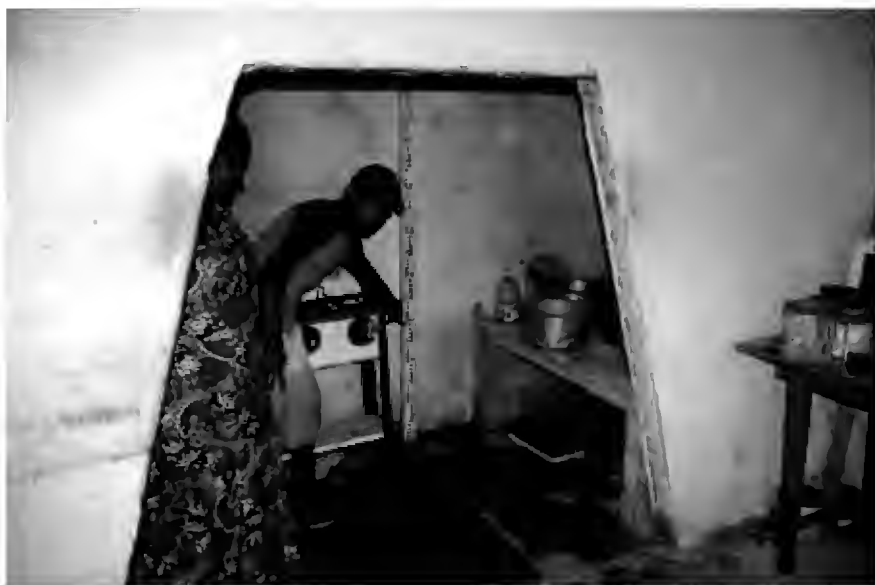
She was cooking in the annex. She extinguished the flame and ran to the main house just as the second wave came around 10 seconds after the first wave. Along the E-W road, the water reached more than 3 m above the ground and violently flowed through to the western lagoon. However, the water level was above knee height in houses beside the road. A watermark beside an oven in her house is 2.0 m above MSL, which accords well with her recollections (Photo 31).

Photo 31. Watermark near the oven at the eastern coast of Gan (August 2005).

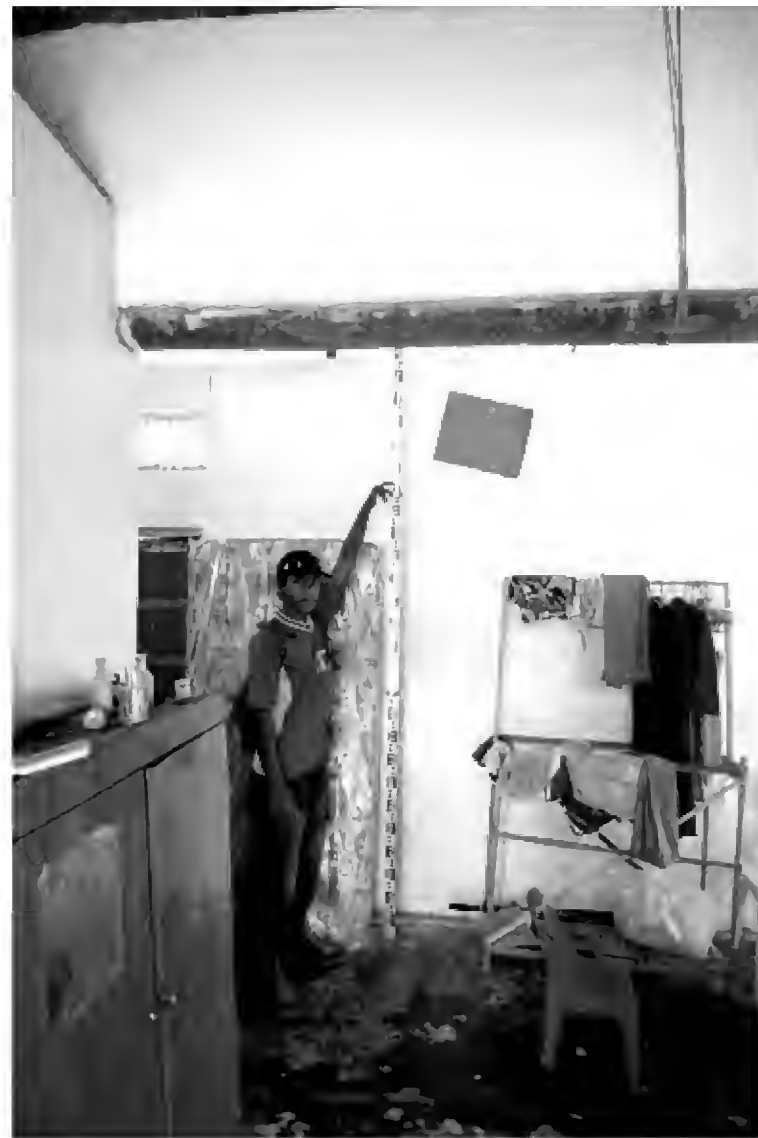
Photo 33. Watermark in a house in the eastern area of transect T1 on Fonadhoo (August 2005).

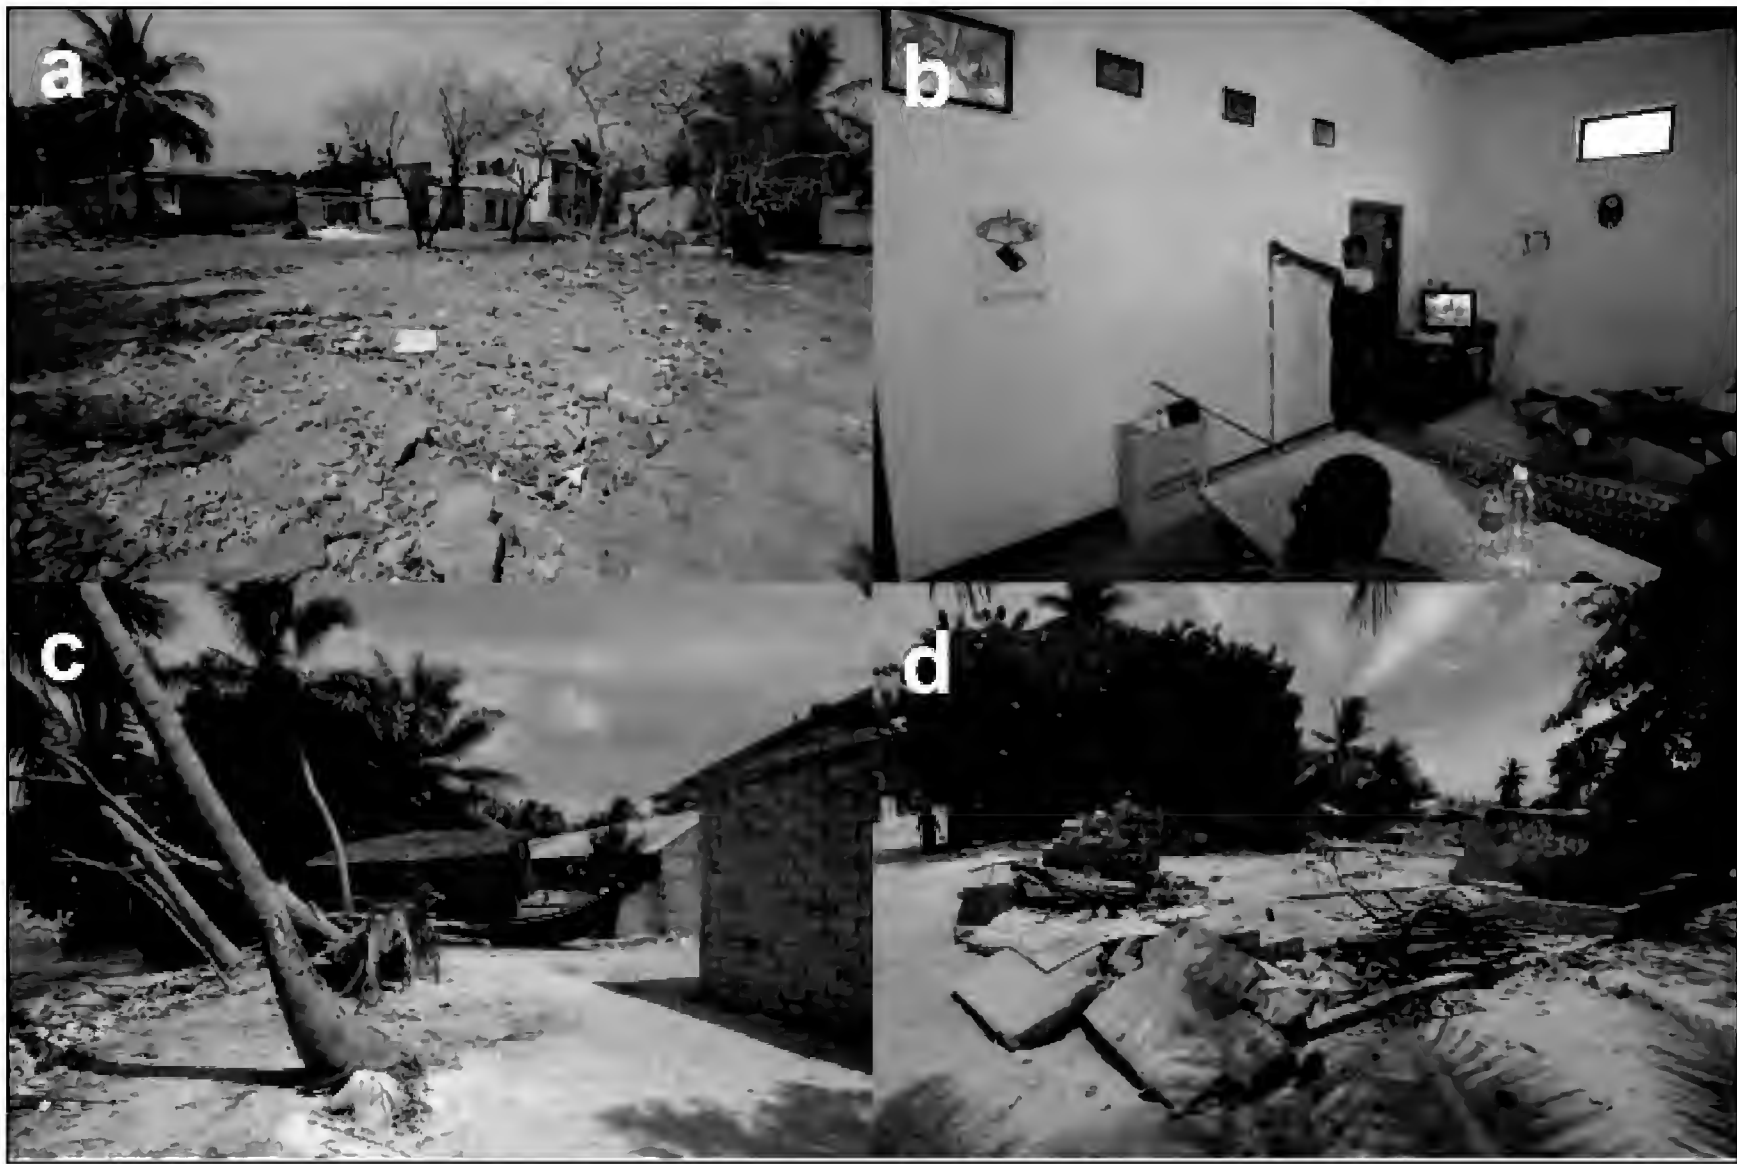
According to local residents, the first tsunami from the east was the highest and caused severe damage. A watermark on a wall in a living room in the easternmost house was found 2.4 m above MSL (Photo 9b). Two waves then arrived from the northwest (from the lagoon) 15 and 30 minutes after the tsunami from the east. The run-up heights of these waves were lower than the first tsunami from the east, with the second wave from the NW being the lowest. A watermark on a wall at the western coast was 1.6 m above MSL.

A dhoni (fishing boat) was run up the beach (Photo 9c) and many walls collapsed (Photo 9d) along the western coast. Damage along the lagoon coast was worse than on Maafushi. The higher run-up height and lower land level (ca. 0.2 m lower than Maafushi) appears to be the reason for extensive damage along Graidhoo's western coast.

Photo 9. Post-tsunami photographs of Guraidhoo (February 2005). a: settlement area completely destroyed at the eastern coast; b: watermark in the living room of the easternmost house; c: dhoni run up at the western coast; d: destroyed wall at the western coast.
